ASSESSMENT OF TWO CITY OF FRANKLIN CEMETERIES, FRANKLIN, TENNESSEE

Chicora Research Contribution 559

Michael Trinkley
Debi Hacker

September 2014

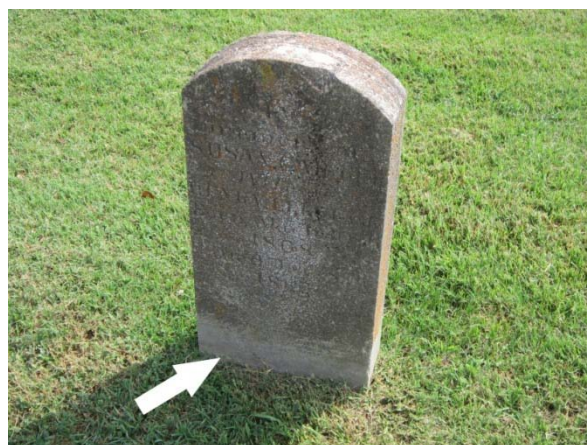
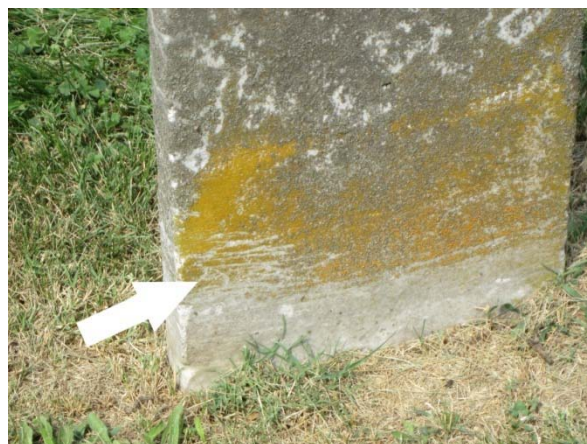
Figure 57. Examples of nylon string trimmer damage at Rest Haven Cemetery.

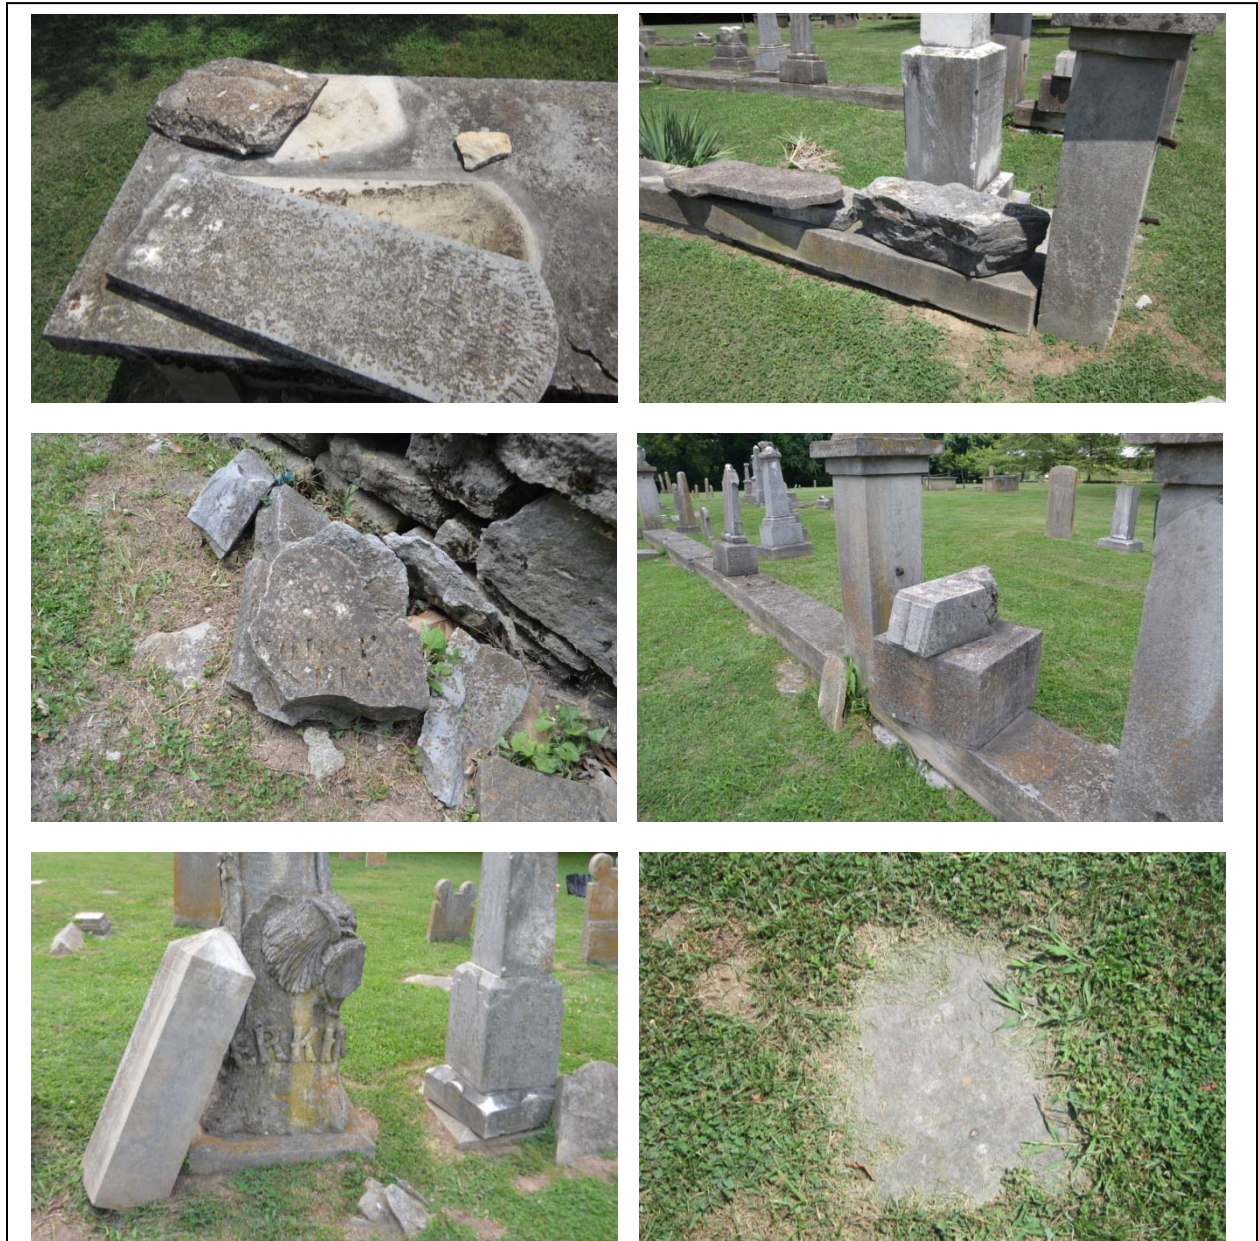
Figure 61. Orphan stones in City Cemetery. Upper left shows stones set on a box tomb for so long that stains have been created. Upper right shows stones stacked on plot coping. Middle left shows stone fragments dumped against the boundary wall. Middle right, stones set on plot coping. Lower left, obelisk fragment leaning against another monument. Lower right, stone fragment almost buried in the soil with no obvious grave association.

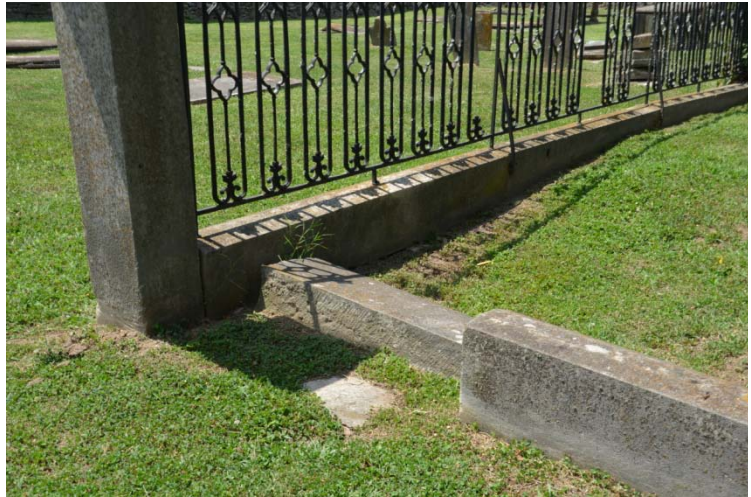
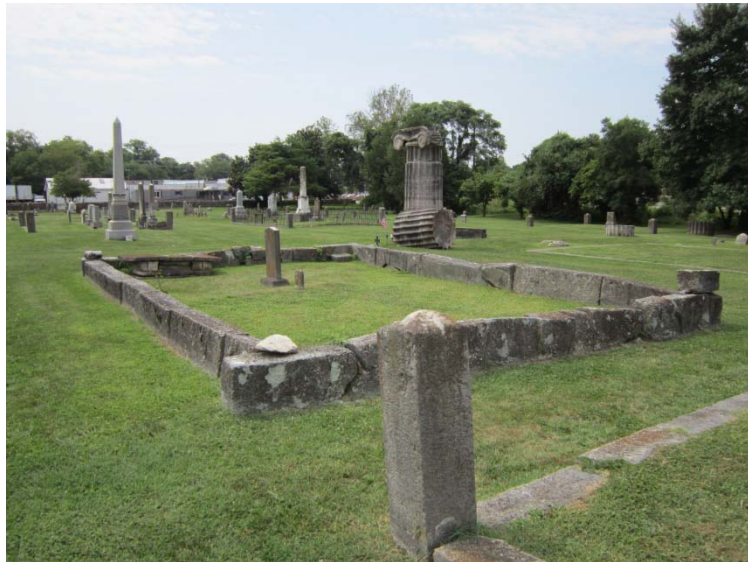
Figure 64. Displaced or damaged curbs and copings. Upper photo shows displaced coping in City Cemetery. Lower photo shows broken and badly displaced wall coping at Rest Haven Cemetery.

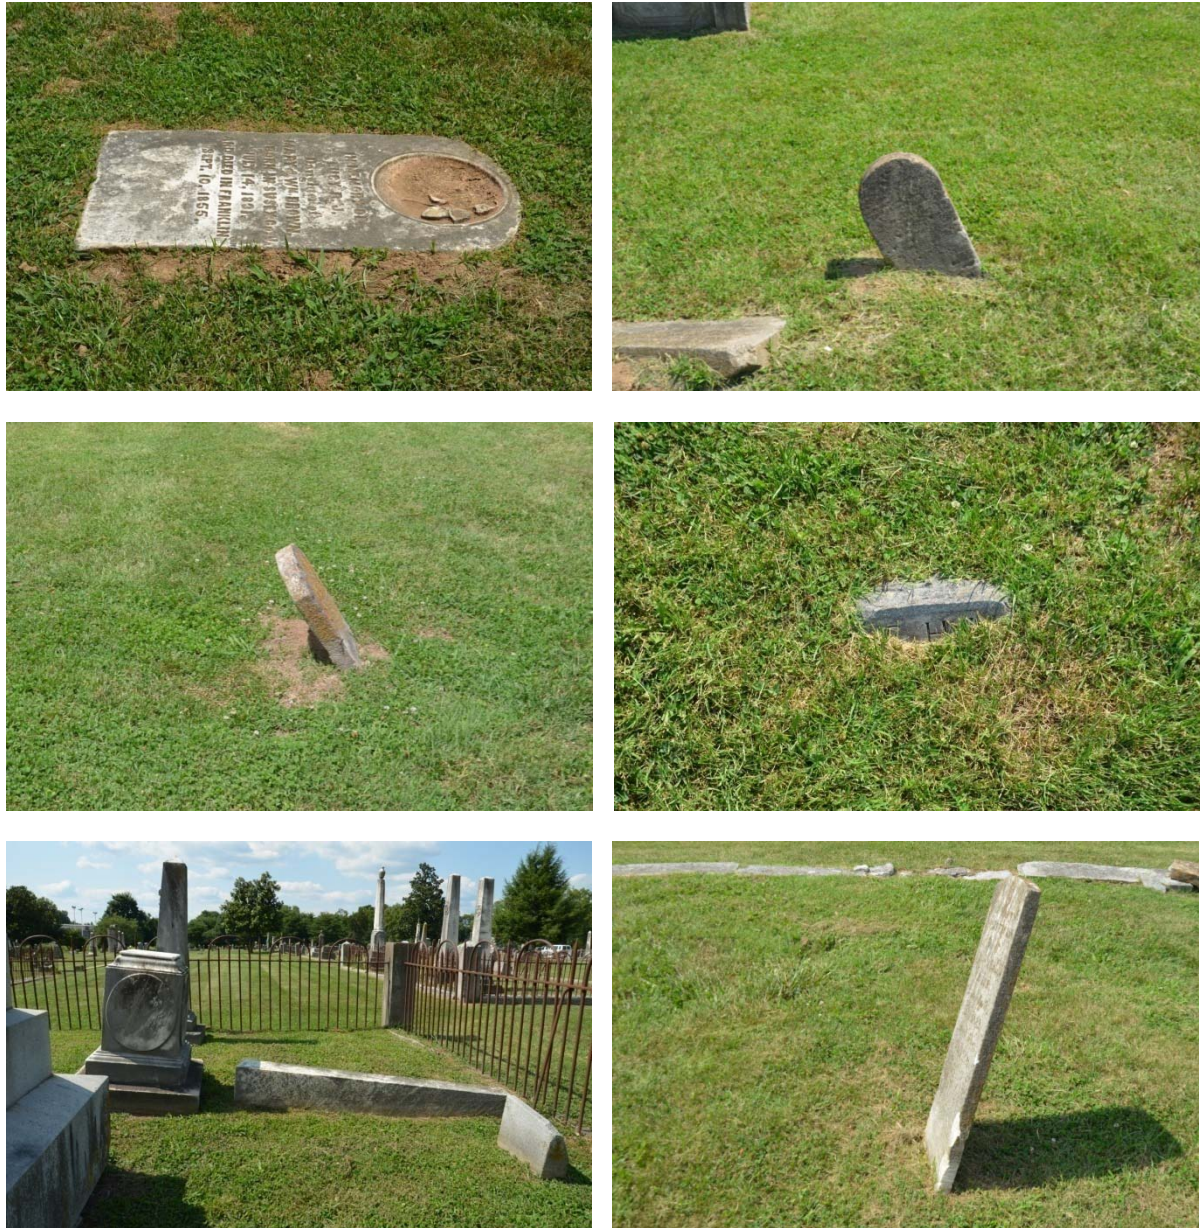
Figure 67. Examples of stones requiring resetting. Upper left, die on base that has collapsed. Upper right, tilted footstone. Middle left, tilted footstone. Middle right, sunken granite footstone being damaged by mowing. Lower left, toppled obelisk that requires resetting. This monument will require lifting equipment and rigging. The bases must first be leveled, and the bases and obelisk shaft drilled for the installation of a stainless steel pin. Bottom right, tilted headstone that requires resetting.

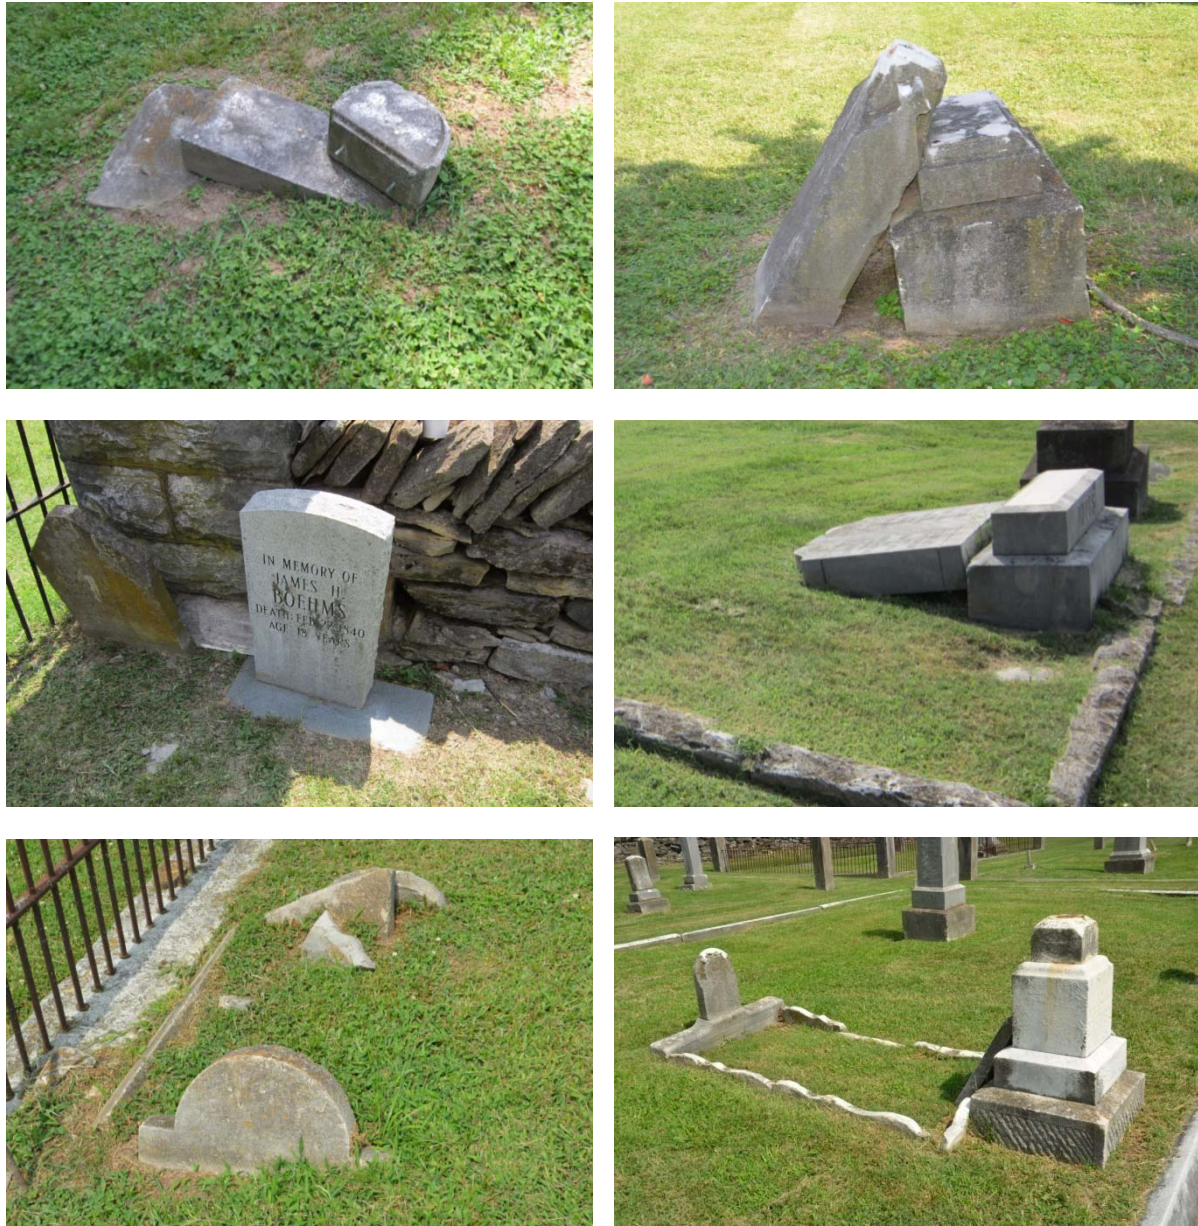
Figure 68. Examples of die on base and cradle grave damage. Upper left shows a die on base. Still present are two ferrous pins in the die which must be replaced with fiberglass or stainless steel pins prior to resetting. Upper right is a die on base that because of its height will require pinning. Middle left shows a modern granite die on base that has shifted significantly and requires resetting. Middle right shows a toppled die on base that requires leveling and pinning as part of resetting. Lower photos show cradle graves that require resetting and repair.

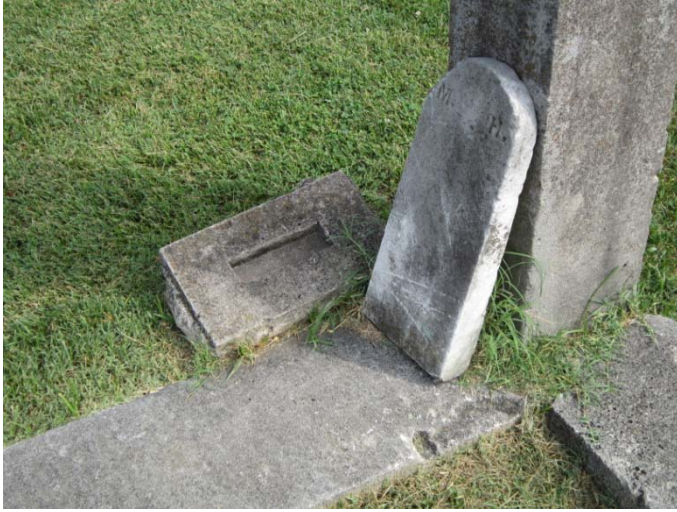
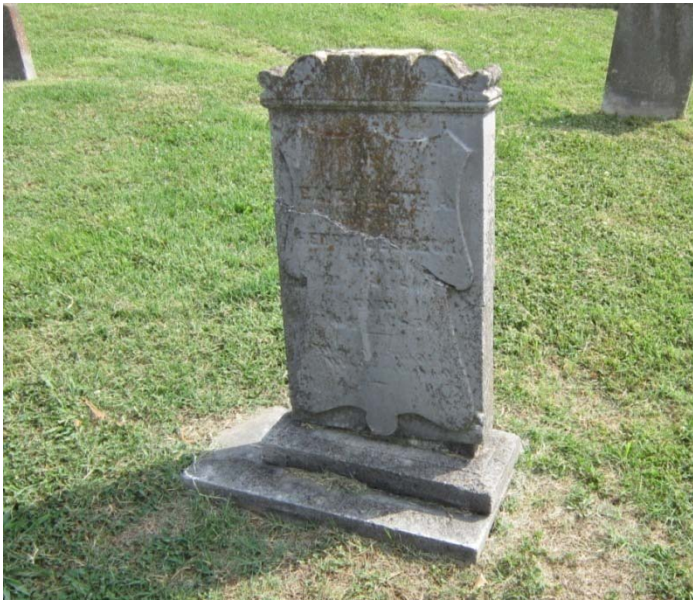
Figure 69. Examples of tab in socket stones. Upper photo shows a stone entirely out its socket. Lower photo shows a stone with a tab loose in its socket.

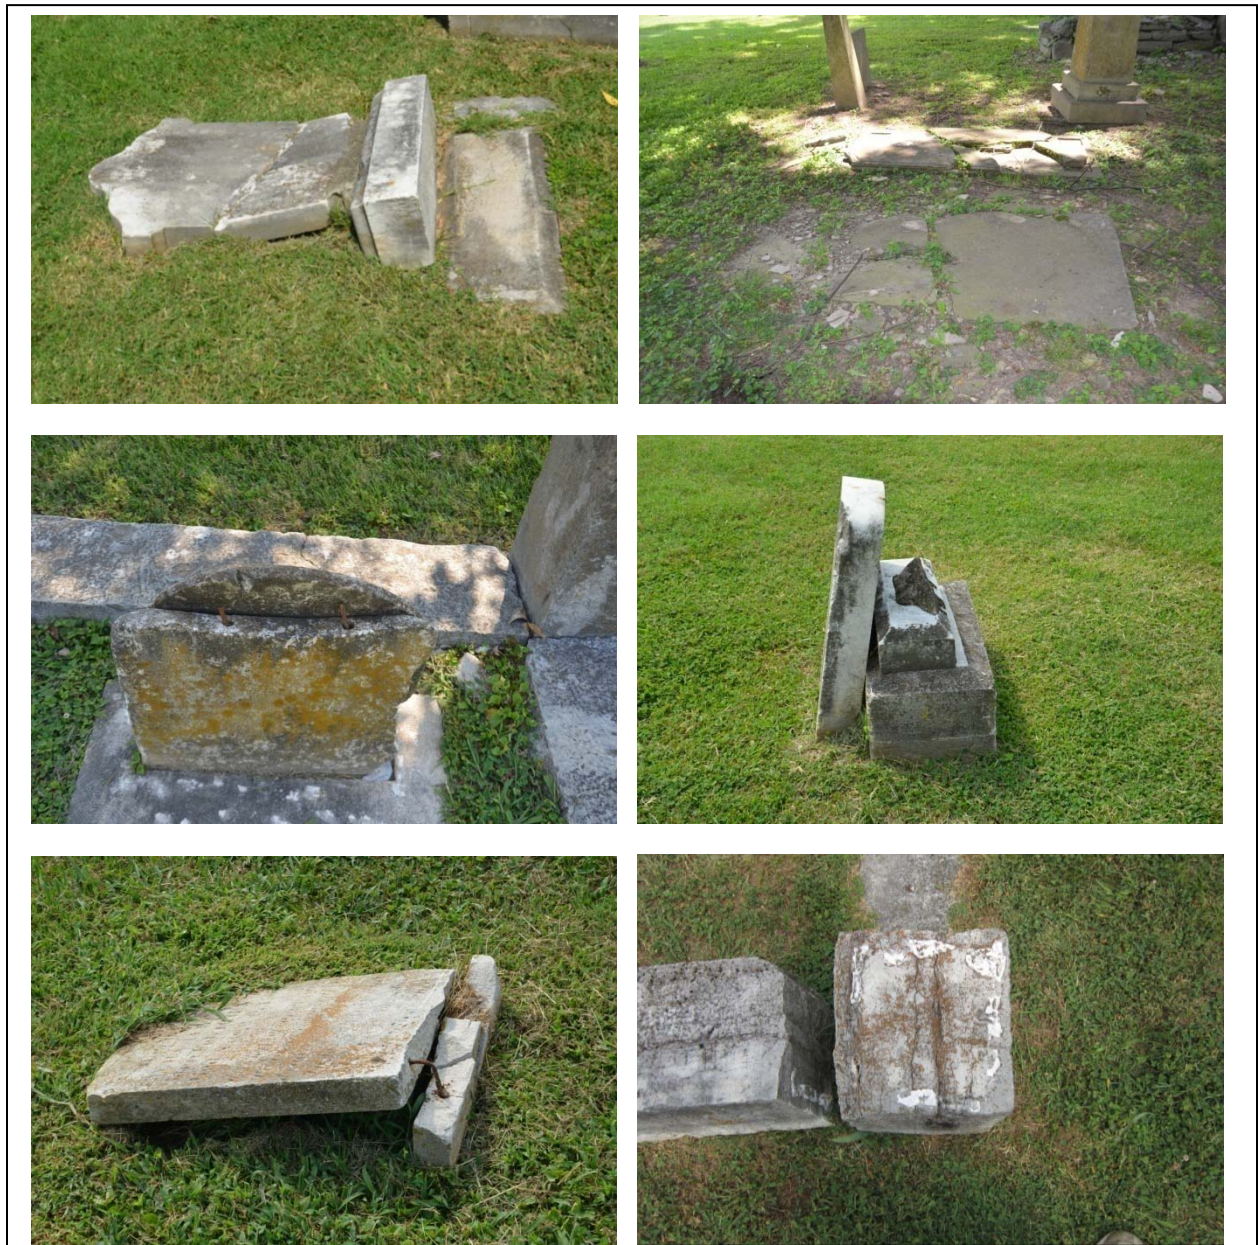
Figure 70. Examples of broken stones. Upper left shows a die on two bases. When the stone fell or was pushed over, the impact of hitting the ground caused the die to break. Upper right shows a badly broken marble ledger. Middle left shows a tab in socket with the die broken and use of ferrous pins in a failed repair. Middle right shows a broken tab in socket. Lower left shows a headstone and use of ferrous pins in a failed repair. Lower right shows a failed simple epoxy repair.

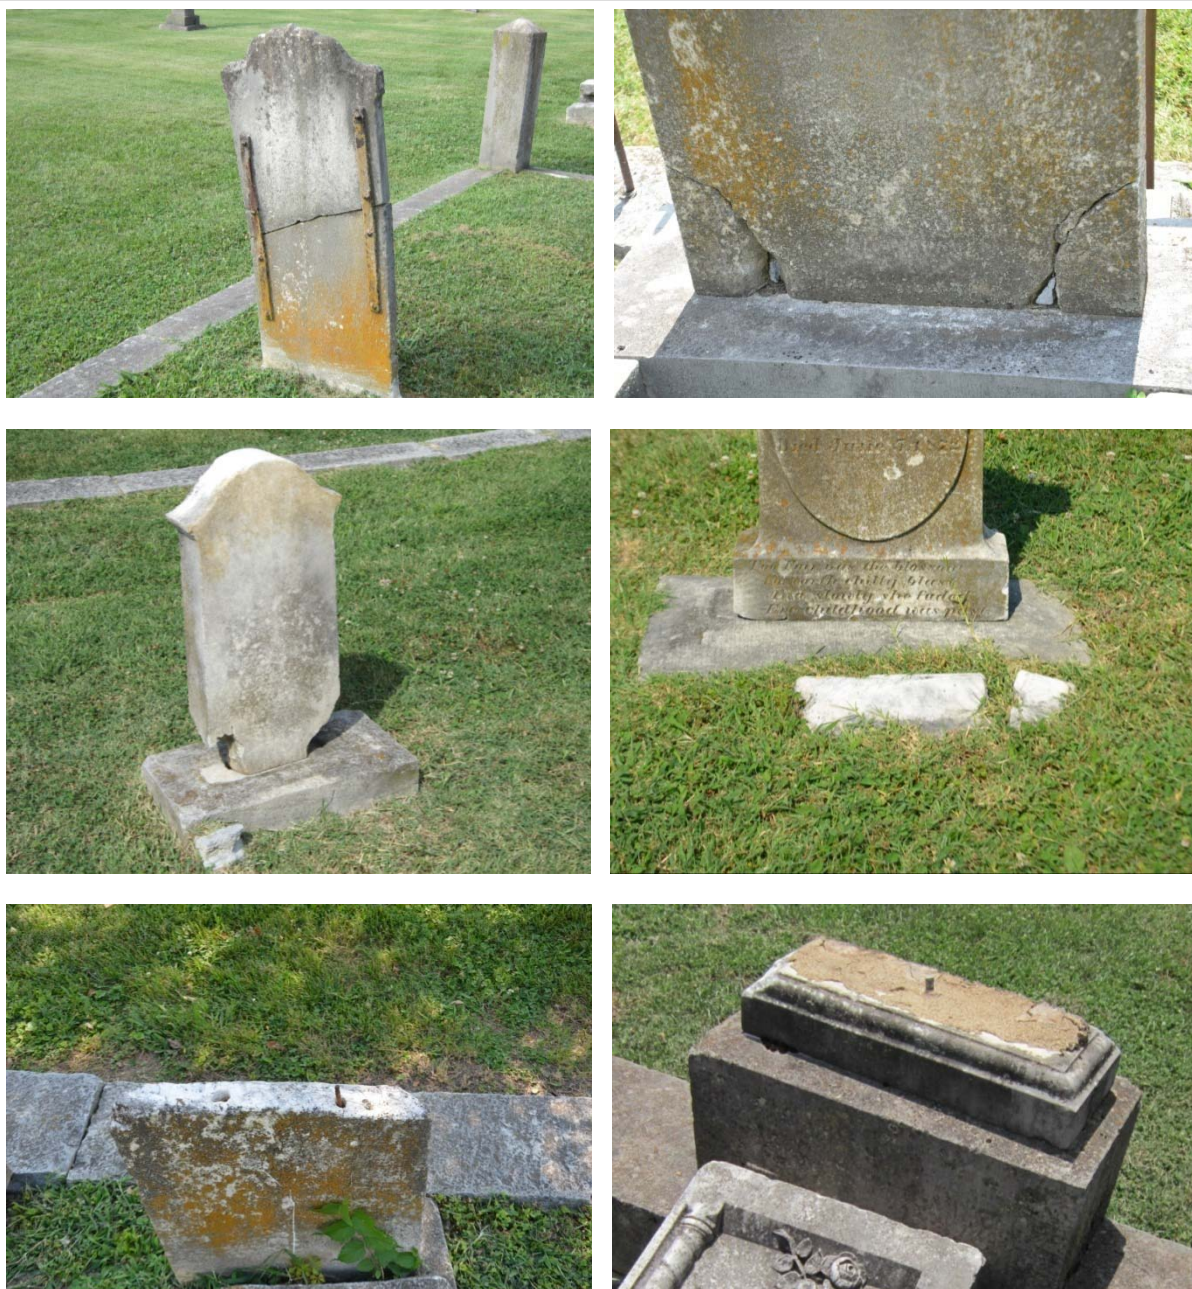
Figure 71. Examples of ferrous pins and iron jacking. Upper left shows a headstone reinforced with iron bars and bolts, all of which are corroding. Upper right shows the die cracking as a result of iron jacking resulting from two ferrous pins. Middle left shows the next phase in the process, with the corners of the die completely shattered by iron jacking. Middle right shows the loss of the middle base (in the grass, foreground) as a result of iron jacking. Lower left shows inappropriate repair using ferrous pins. Lower right shows die on base setting using a ferrous pin.

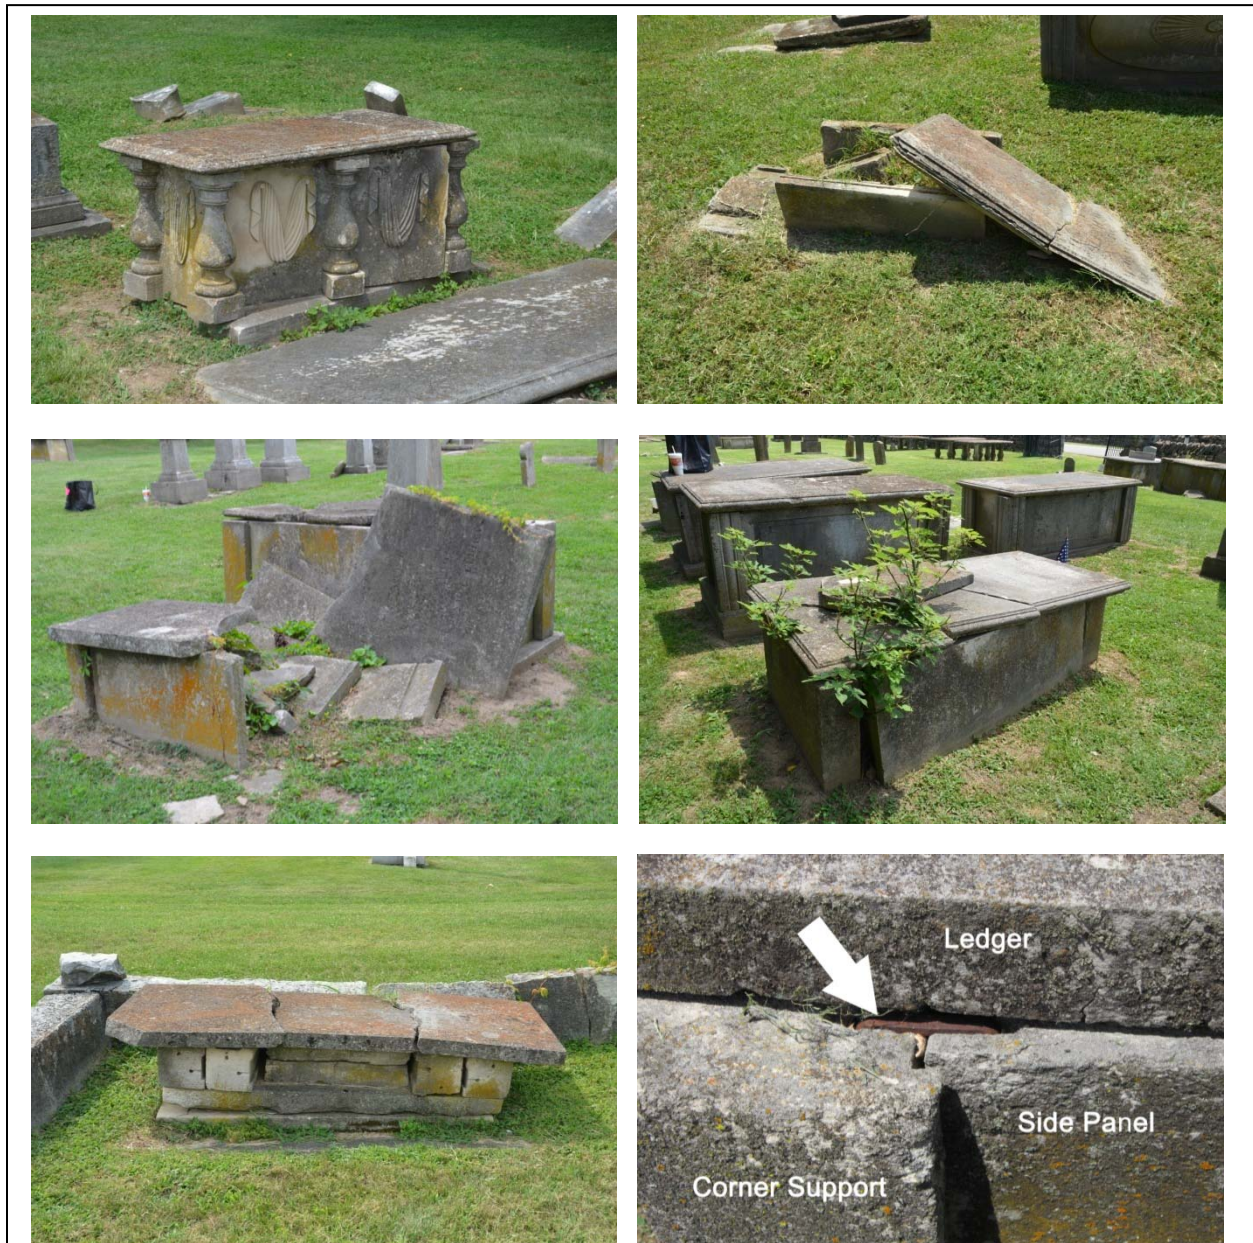
Figure 72. Box tombs. Upper left shows an ornate example that, while intact, has badly shifted on its base. Without resetting it will collapse and suffer damage. Upper right shows a box tomb that has collapsed, resulting in the breakage of the ledger – dramatically increasing repair costs. Middle left shows a partially collapsed box tomb with both the side walls and ledger broken. This box tomb does not have corner posts. Middle right, a box tomb that is badly damaged, but still standing. It also reveals much vegetation growing out of the box, which will eventually cause even more damage. Lower left shows a collapsed box tomb with its parts neatly stacked. Lower right shows a ferrous dog in a still standing box tomb.

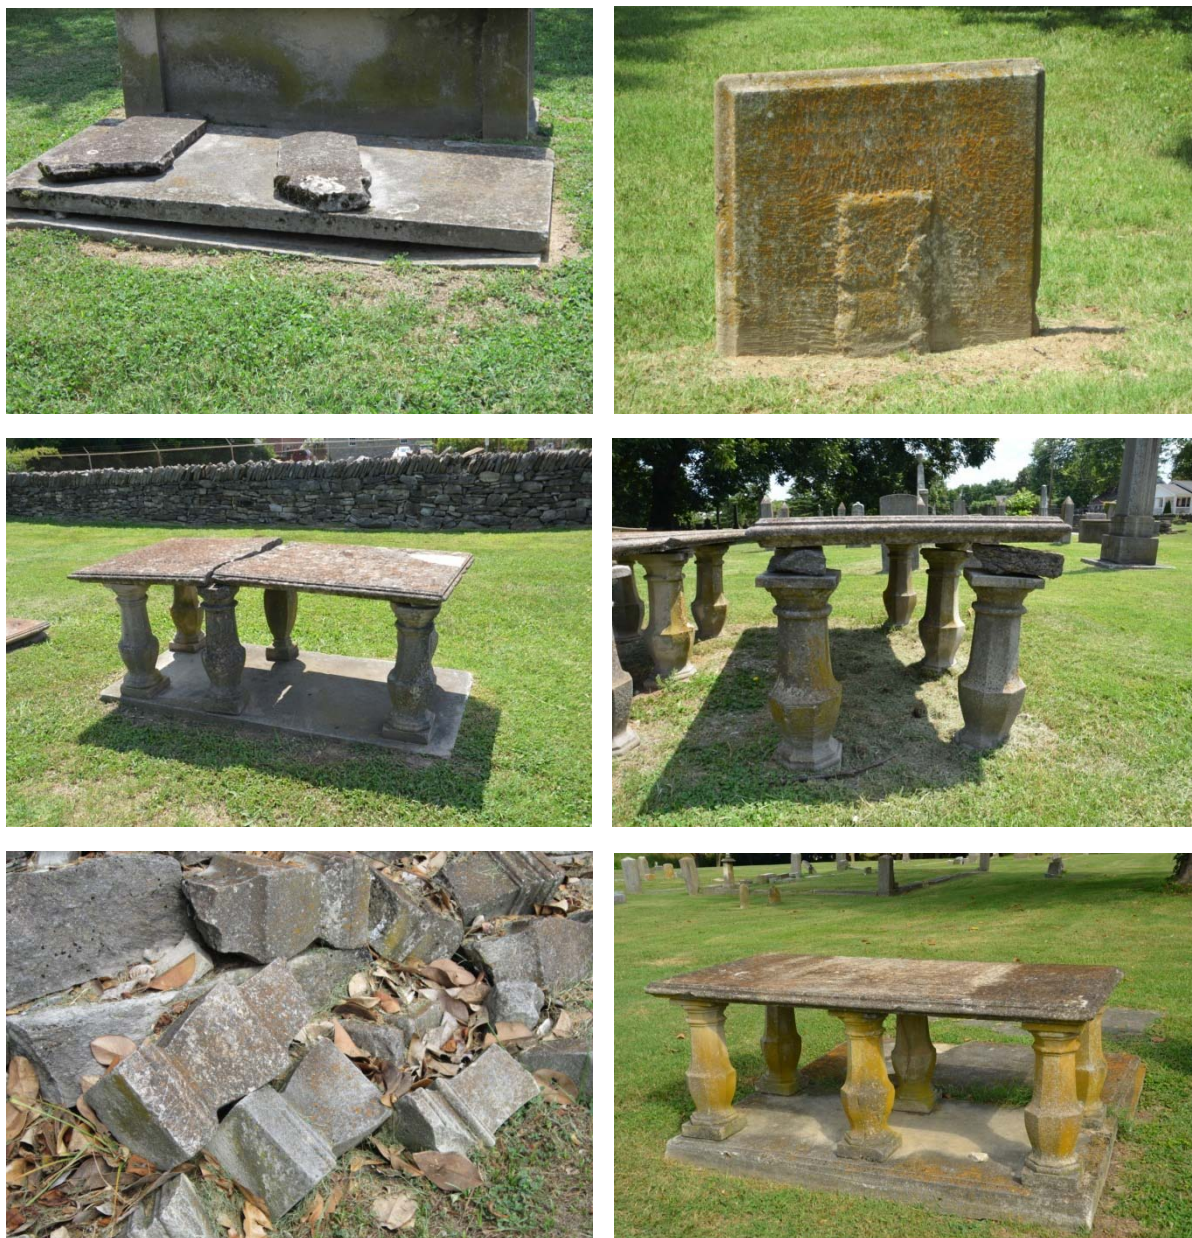
Figure 73. Examples of box and table tombs. Upper left shows a collapsed box tomb. The bottom slab is broken and anyone walking on the supported ledger will cause it to break. Upper right shows a ledger from a box tomb reset as a headstone. Middle left shows a table tomb that, while still standing, is unstable. If it collapses it will likely further break the ledger and possibly one of more of the legs. Middle right shows another unstable table tomb where parts of other monuments have been used in an effort to level the ledger. Lower left shows broken legs from Rest Haven Cemetery dumped along the wall. At that cemetery many of the ledgers were probably originally box or table tombs. Lower right shows one of the few still standing table tombs in Rest Haven Cemetery. In the background are two ledgers that were probably originally table tombs.

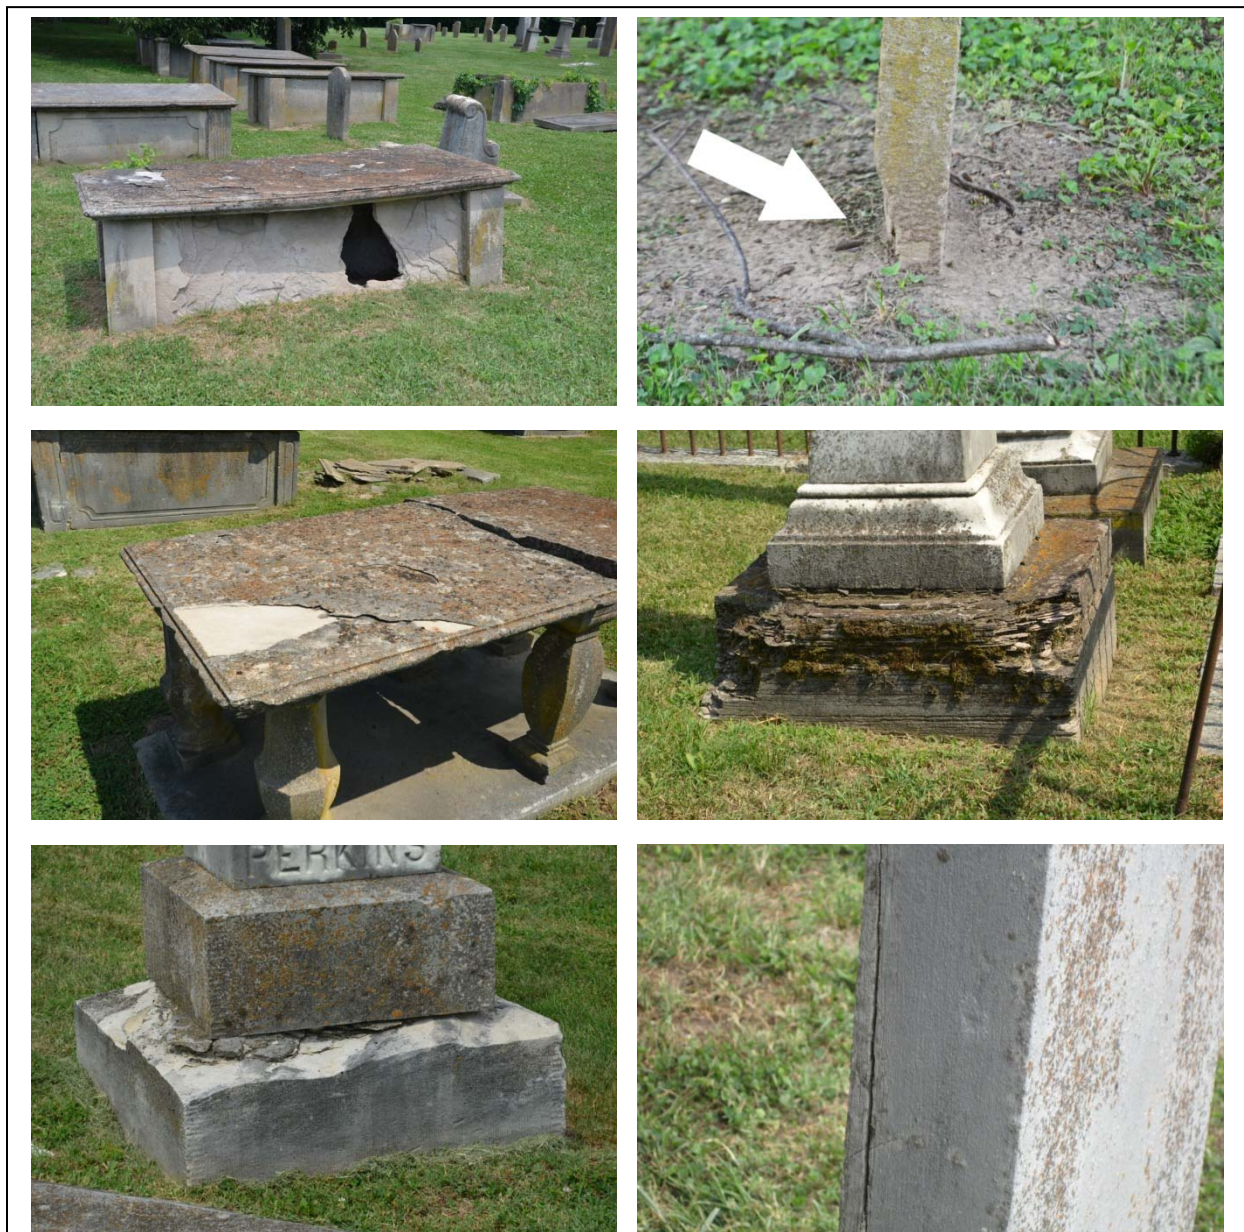
Figure 74. Spalling. Upper left shows a sandstone side panel of a box tomb with heavy spalling or exfoliation to the point that a large segment has been lost. Upper right shows spalling at the base of a headstone resulting from salts. Left unchecked, the headstone will eventually collapse. Middle left shows a spalling (and broken) ledger. Eventually all of the inscription will be lost. Middle right shows a badly deteriorated base where the bedding planes are clearly visible. Bottom left shows another spalling base that is causing instability in the overhead obelisk. Lower right photo shows a crack developing in a headstone. Left untreated this will cause the carved face to spall off the monument.

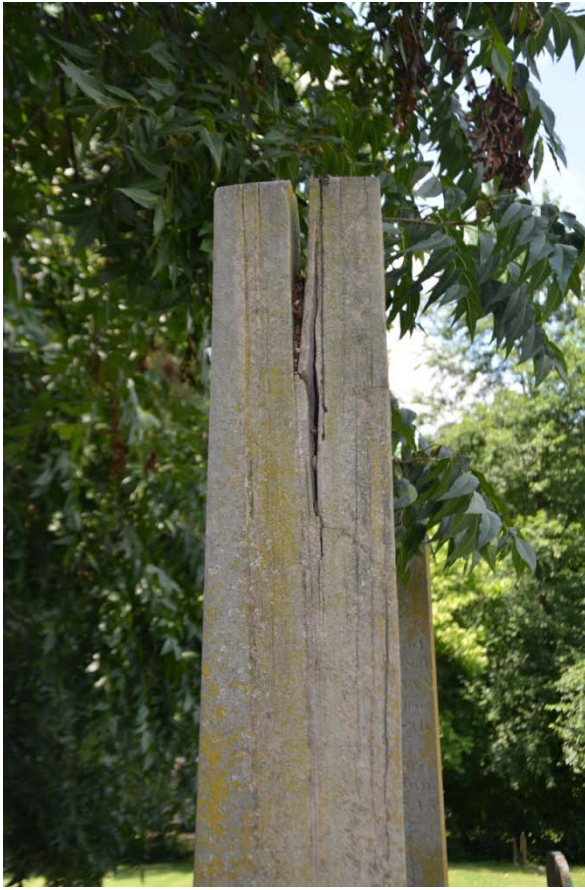
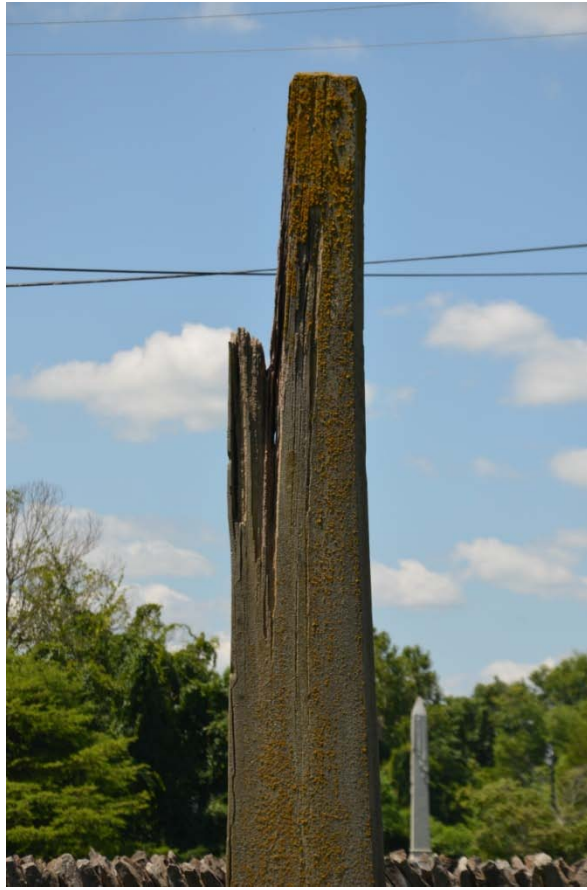
Figure 75. Extensive spalling on two sandstone obelisks in City Cemetery.

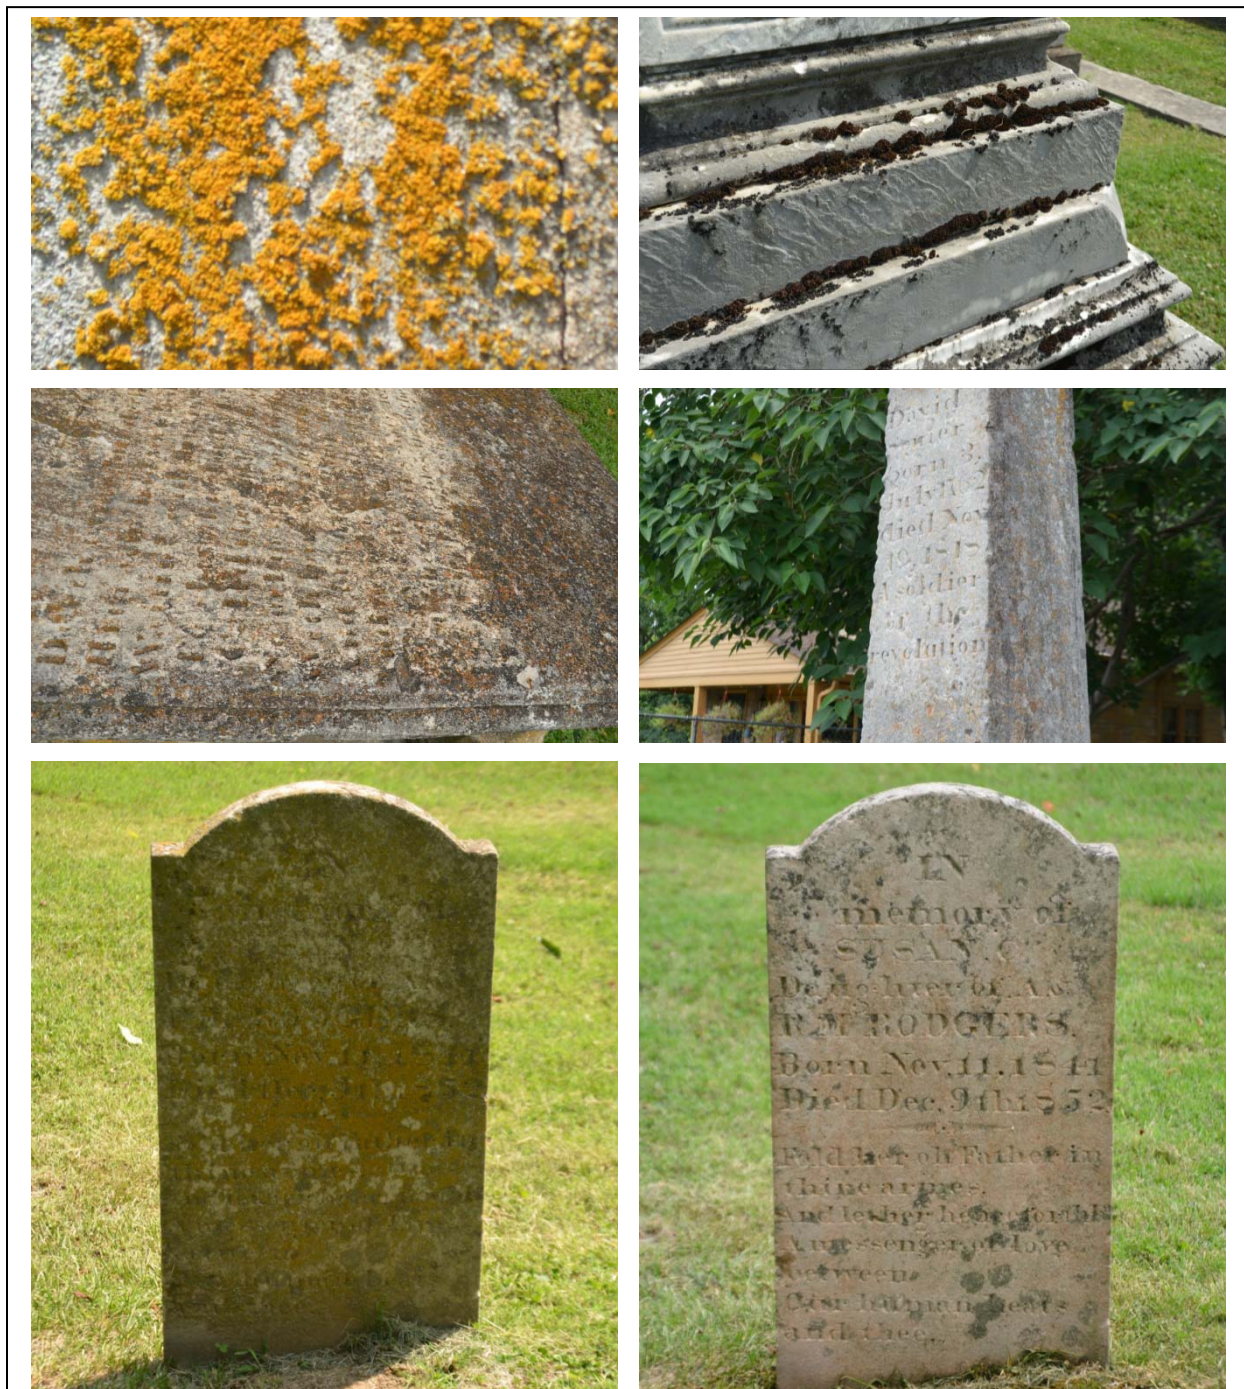
Figure 76. Cleaning issues in the cemeteries. Upper left shows a close-up of lichen on a stone at City Cemetery. Upper right shows a different lichen form at Rest Haven Cemetery. Middle left shows a table tomb harshly cleaned in an effort to read the inscription. Middle right shows an improperly cleaned inscription on an obelisk; the remainder of the monument was left soiled. Bottom shows a stone before and 10 minutes after cleaning with D/2 Biological Solution.

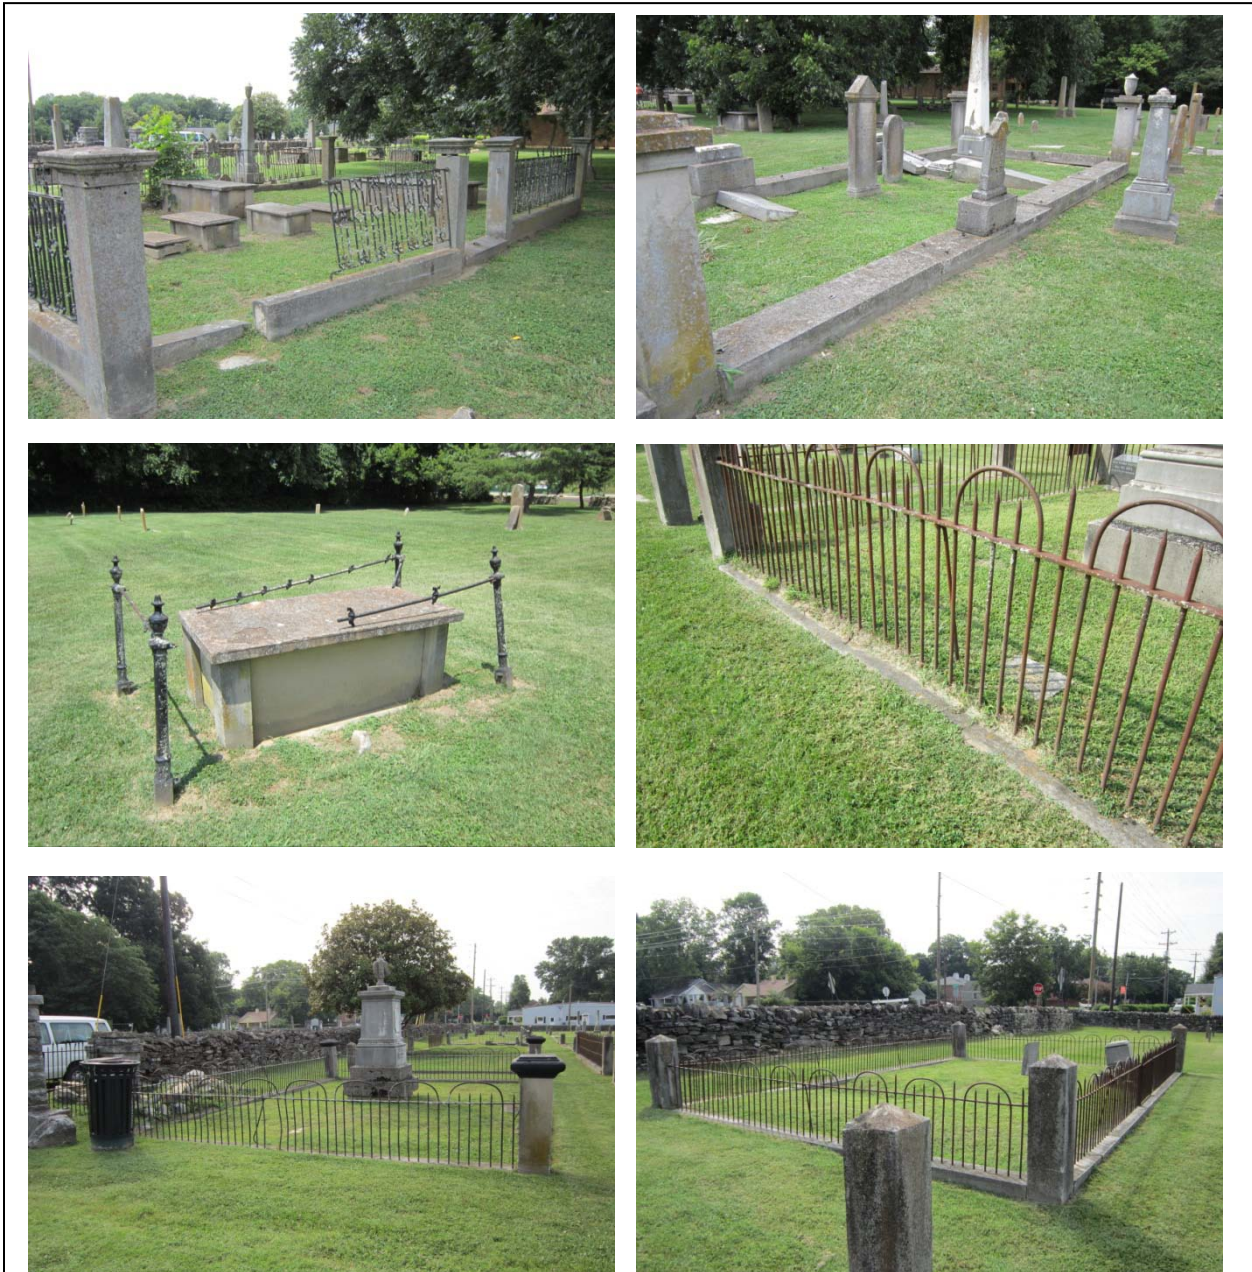
Figure 78. Fence Problems. Upper left shows a fence rated in poor condition. The gate, several sections, and individual pickets are missing; coping is displaced; and the fence requires painting. Upper right shows a fence that has been completely lost, being cut off its stone coping using a cutting torch. Middle left photo shows a fence that is almost entirely missing. Middle right shows grass growing over the coping and bottom of the ironwork. Lower left shows a fence classified in fair condition, requiring some structural support and painting. Lower right shows a fence considered to be in good condition that requires only painting.
